NATIONAL PROGRAM FOR INSPECTION OF NON-FEDERAL DAMS  
AMERICAN TISSUE DAM (U) CORPS OF ENGINEERS WALTHAM  
MA NEW ENGLAND DIV OCT 78

Based on the visual inspection and past operational performance the dam is judged to be in fair condition. The dam structure appears to be in good condition but the gate works are in poor condition. The dam is not presently operated.

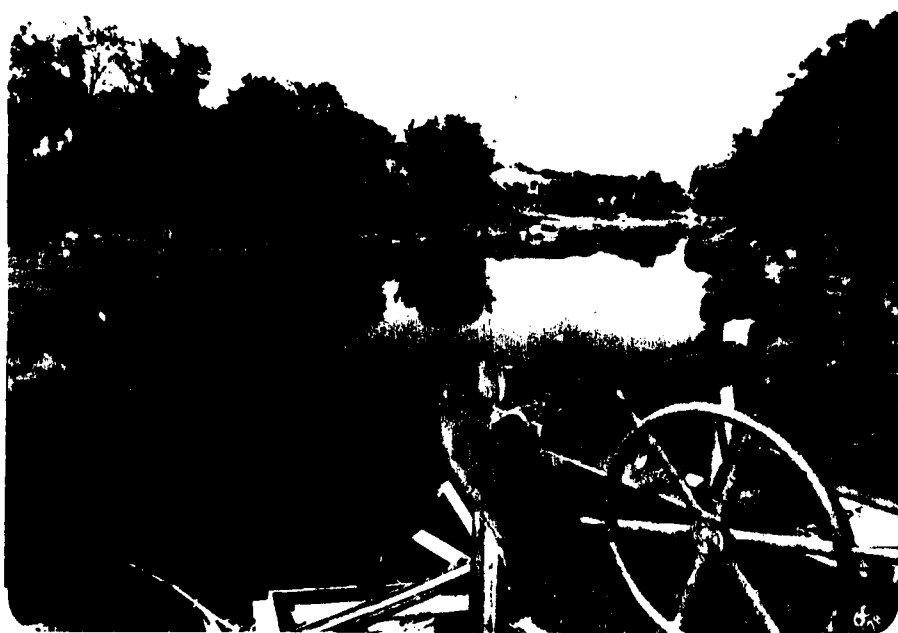
2  
UPSTREAM VIEW

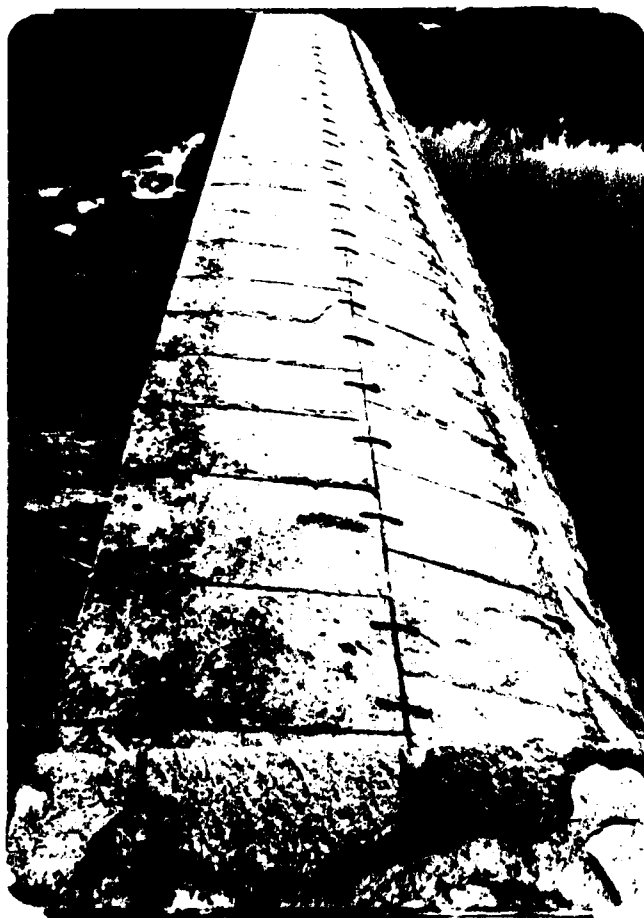
- (f) Some tree and brush growth has occurred in the masonry of the dam. The embankment sections of the dam are tree and brush covered.
  - (g) The cap stones in the spillway are solidly mortared. The iron u-pins which attach the stones to each other are badly rusted but are intact.

7  
DAM SPILLWAY CREST

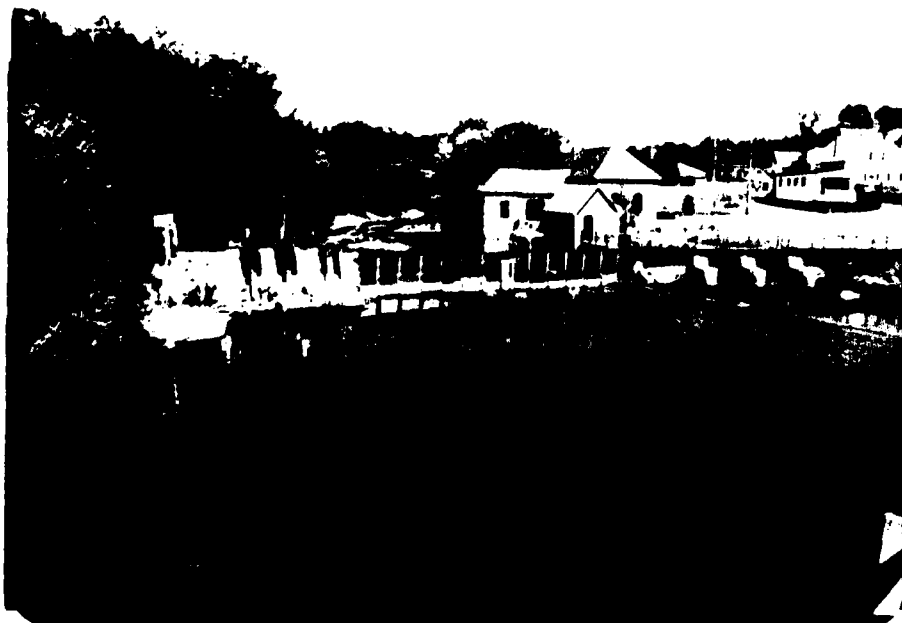
8  
GARDINER WATER DISTRICT DAM

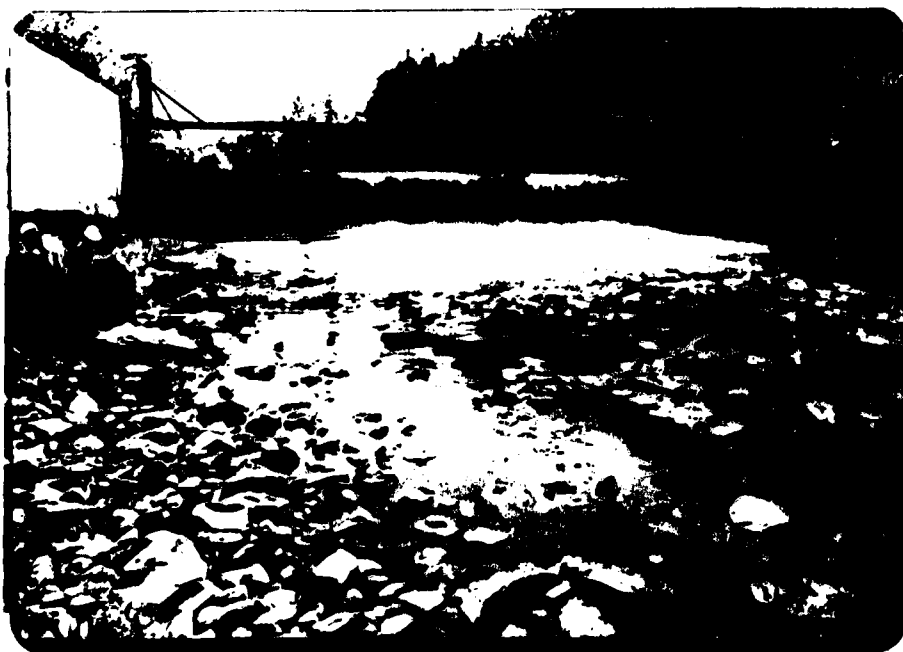
9  
YORKTOWN DAM
